MYOSOTIS LAKE DAM

INVENTORY NO. 670

PHASE I INSPECTION REPORT
NATIONAL DAM SAFETY PROGRAM

SEPTEMBER 1978

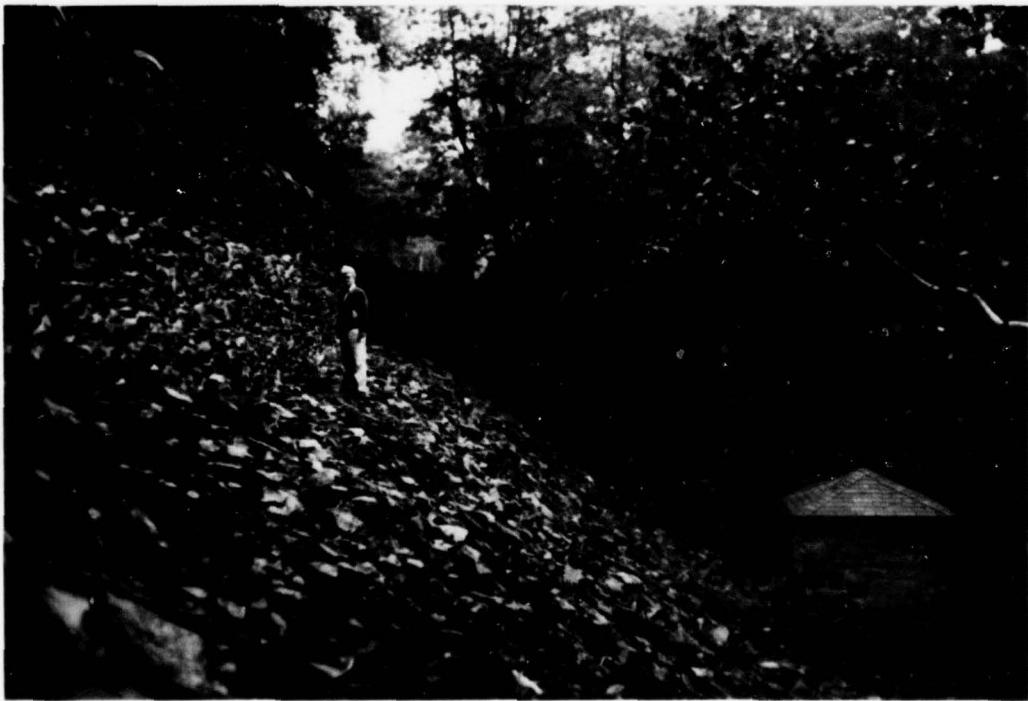
The 12-inch gate valve is housed in a gatehouse built from concrete blocks at the toe of the dam. The valve appeared to be in good operable condition. A small leak around the stem and slight corrosion of the valve body do not preclude a normal functioning of the valve.

DAM, DOWNSTREAM SLOPE AND GATEHOUSE

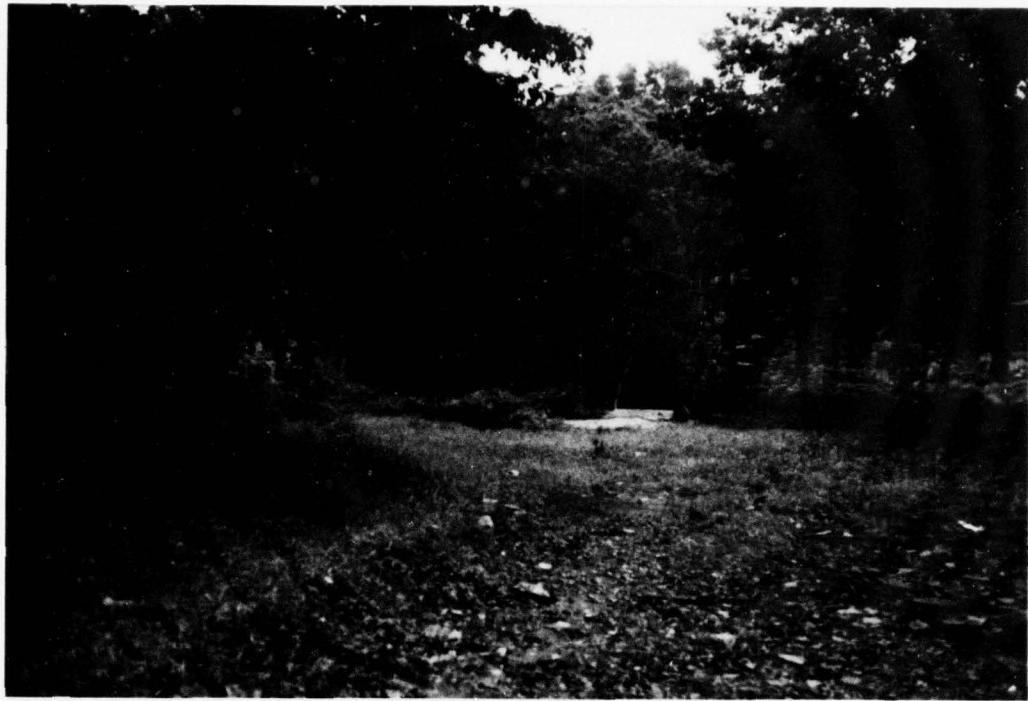
A 5-foot high retaining wall at the left entrance shoulder of the spillway was cracked and upper layers of masonry were dislocated under soil pressure.

SPILLWAY ENTRANCE, LOOKING DOWNSTREAM

10. Abutments Masonry 5-ft high approach wall on the left side of the spillway has cracks, slight dislocation under soil pressure

- a. Remove heavy shrubs and saplings from all locations on the dam.
- b. Repair the spillway slab.
- c. Repair the left side entrance wall of the spillway.
- d. Prepare operation and maintenance manual for the project.
- e. Maintain the record of operation and maintenance.
- f. Establish a program of periodic inspections of the project features.

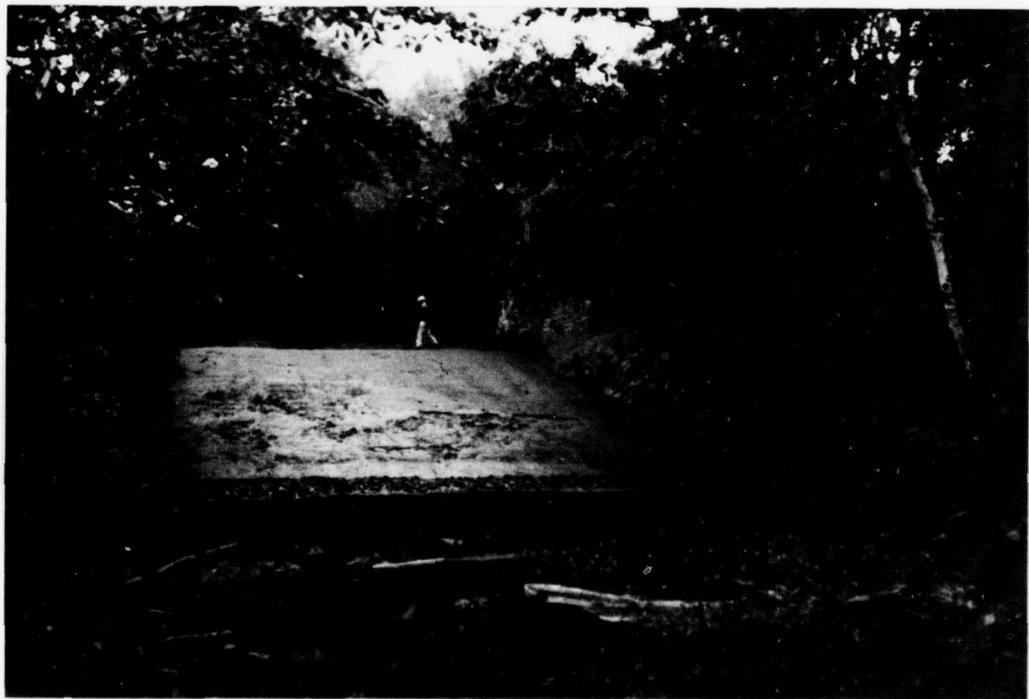
At the time of inspection water level was approximately 2.5 feet below the spillway crest, i.e., at El. 1688.5±. The sloped portion of the spillway floor has been gunited previously over the reinforcing steel mesh. At the time of inspection there were cracks and erosion in several places of it. Some cracks have been patched recently. The lower horizontal portion with embedded stones for energy dissipation was in good shape. Scouring downstream from the spillway was localized and of a limited significance.

SPILLWAY EXIT, LOOKING UPSTREAM

1. Concrete Surfaces Masonry of vertical exposed o/s face of dam is in good condition. Masonry spillway slab was provided with re-steel bars and quinited facing, which has been washed away in several places.
2. Structural Cracking None visible
